Annex AA

**Aurizon Network – Safety Alert Examples, various
2012**

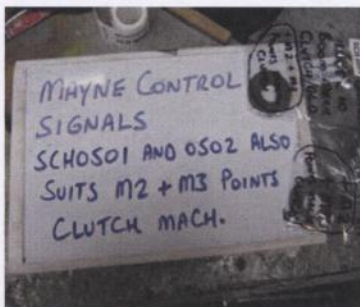
Model 10boom gate

- Recent samples taken by Queensland Rail Asset Inspectors of some models of **boom gate and points machine clutch mechanisms**, have identified the presence of the Asbestos Containing Material (ACM), chrysotile. At this stage, testing and preliminary investigations have indicated the following assets may be impacted:
 - M3A points machines;
 - M23A points machines;
 - M70MK1, MK2 and MK3 points machines;
 - Nippon KA140C, KA140E and KA302A points machines;
 - Model 10 boom gates
- Confirmation is also being sought from the manufacturers involved. Specifically to identify serial numbers of the affected models.
- These components were manufactured between 1952 and 1989, however may have been installed later, refurbished or used from remaining stock.

- The only activity to be performed on the identified Points Motors and Boom Gates is emergency maintenance required to keep the network operative

- To perform emergency repairs on the listed Points and Boom Gate motors, the supplied Work Method Statement must be followed.

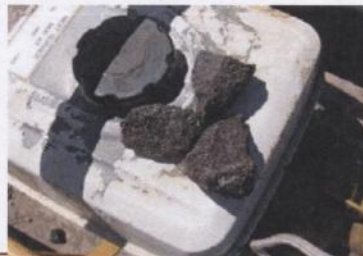
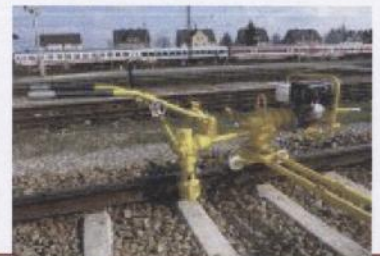
On the 18th October 2010 a track team from Queensland Rail Construction were using a Grinding Machine (see pictured). The machine had been stowed on site uncovered and exposed to the elements.

The Machine was operated following a pre-use inspection and after a short period of use, the grinding stone shattered.

The investigation revealed the stone had been wet due to being stowed uncovered in the open and had been exposed to rain.

When a wet grinding stone heats up during operation, the water within expands (Steam) causing the potential for the stone to fracture and fly apart, which is what occurred in this incident. This applies equally to grinding discs.

- As part to the pre-use inspection all competent operators must inspect the grinding stone / disc to ensure it is dry. Grinding must not commence if the grinding stone / disc is WET.
- Wet stones / discs must be tagged as OUT OF SERVICE – WET STONES / DISCS must be removed and replaced.
- Grinding machines must always be stowed in a dry place, be covered or have the grinding stones/discs removed and stored separately in a dry place.
- All work method statements or procedures must be reviewed and updated where required to include the controls listed above and re-signed by those performing the work.
