Attachment 6: GHD Peer Review of West Moreton System DAU2 Maintenance Costs 2020-21 to 2024-25

Peer review of Queensland Rail's proposed maintenance expenditure for DAU2

Queensland Rail

27 July 2018

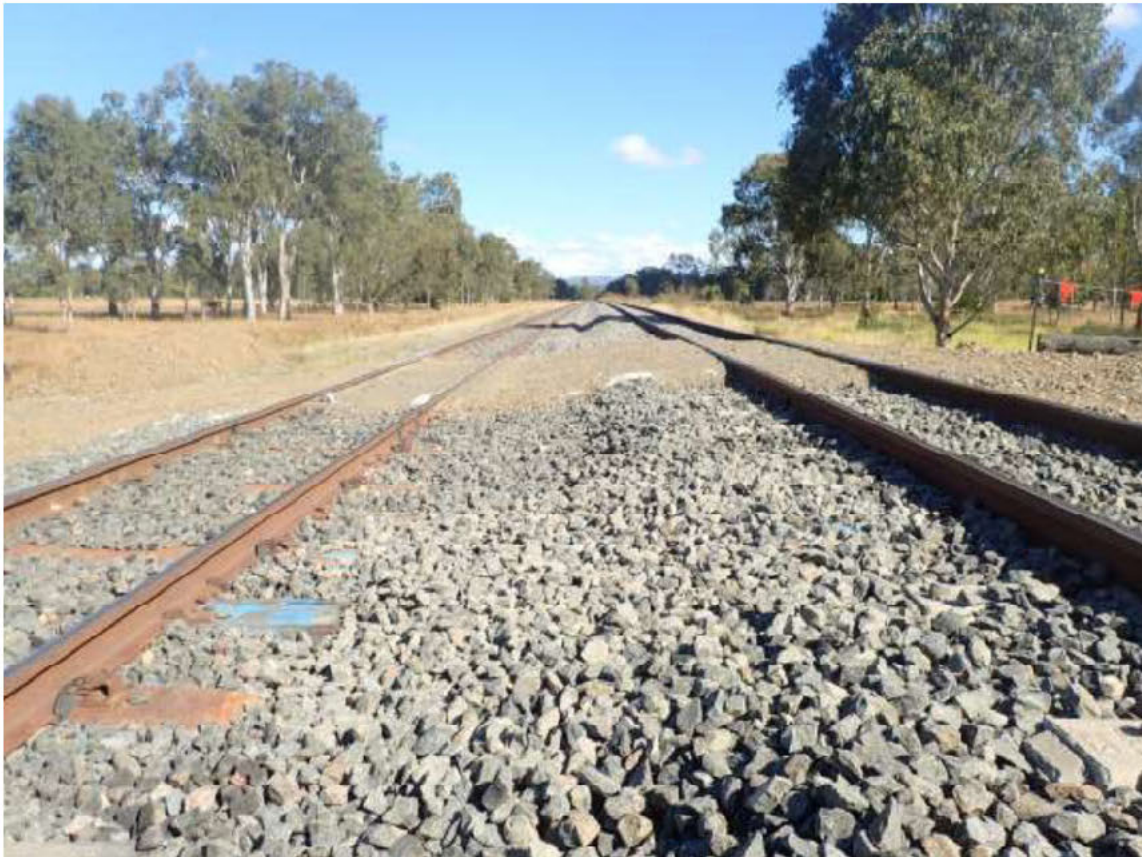
Site 8 had issues with the above described formation as evidenced by the vegetation coming through the sleeper bays, as shown in Figure 3 and Figure 4 below. Figure 2 below shows an example of recent track lowering works performed near Laidley, with the difference in track height clearly noticeable (although this is not suggestion that the down-road track is excessively high, this is shown to demonstrate the actual work).

Figure 2: Recent track lowering works near Laidley on the up-road track

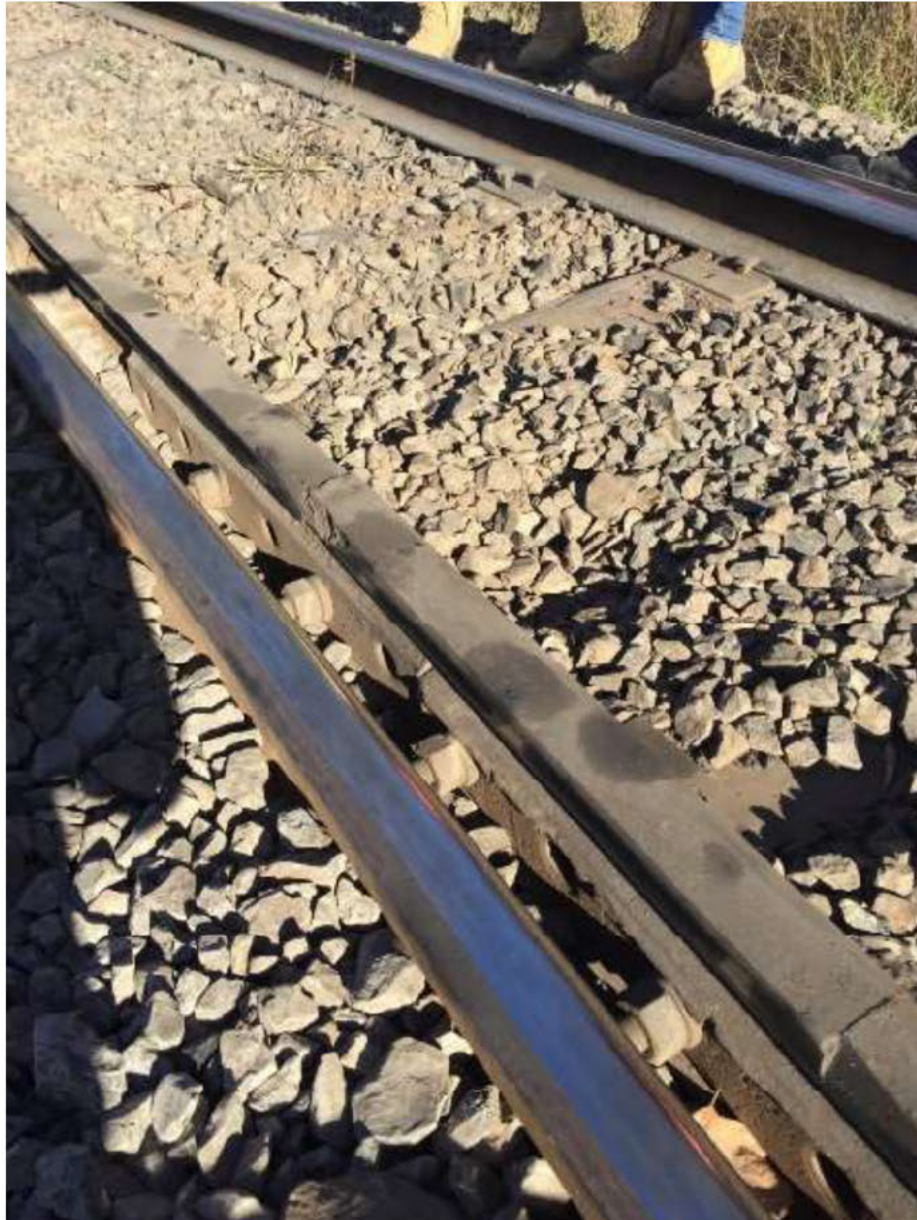
Figure 3: Poor formation conditions evidenced by the vegetation in the sleeper bays

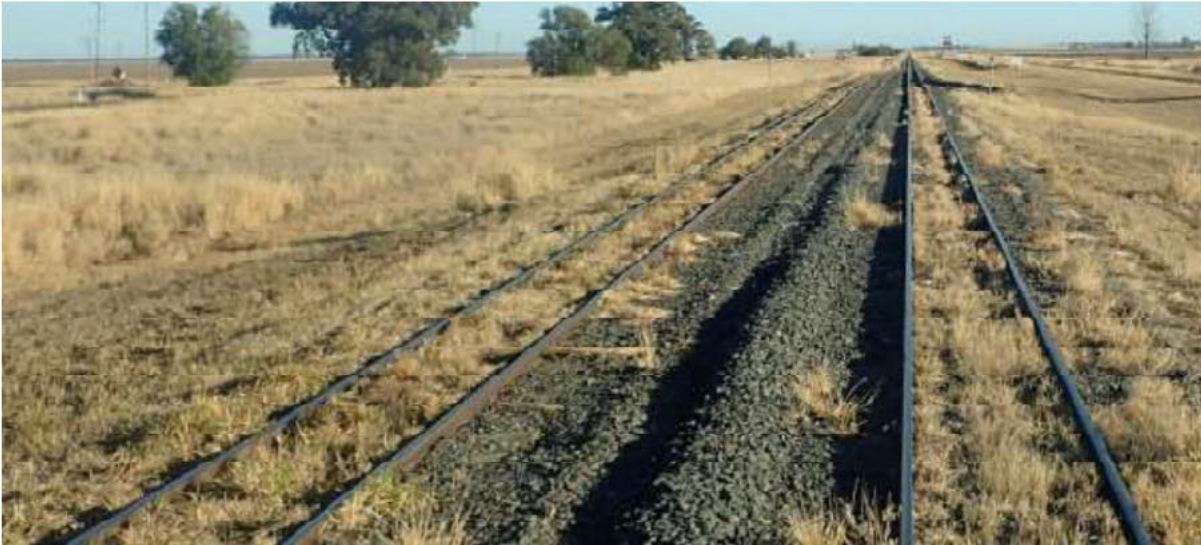
Figure 4: Dense vegetation growth through the track bed in parts of the track between Toowoomba and Miles, a symptom of the non-engineered formation characteristic of the West Moreton System

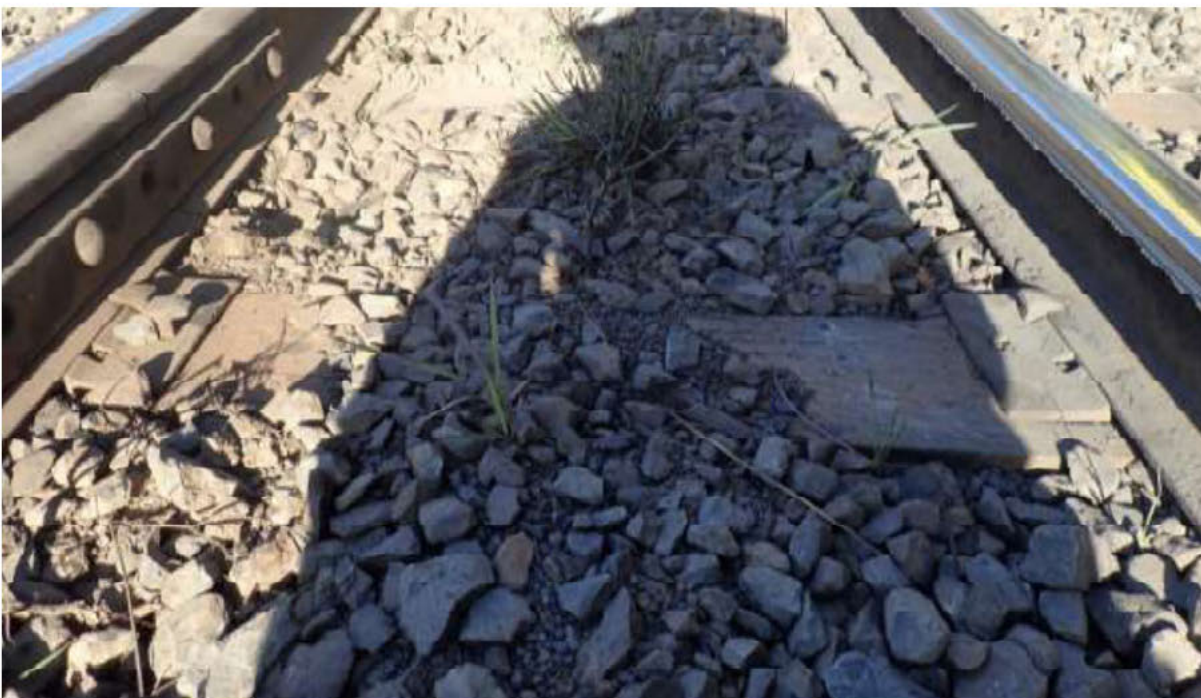
Figure 5 below demonstrates an area in need formation repairs

The vegetation growth suggests that fine particles have been pumped from the formation subgrade and interspersed with the ballast. If left untreated this can cause waterlogging/mud holes and will impede the integrity of the track structure.

Figure 5: Poor formation issues and vegetation growing from track-bed

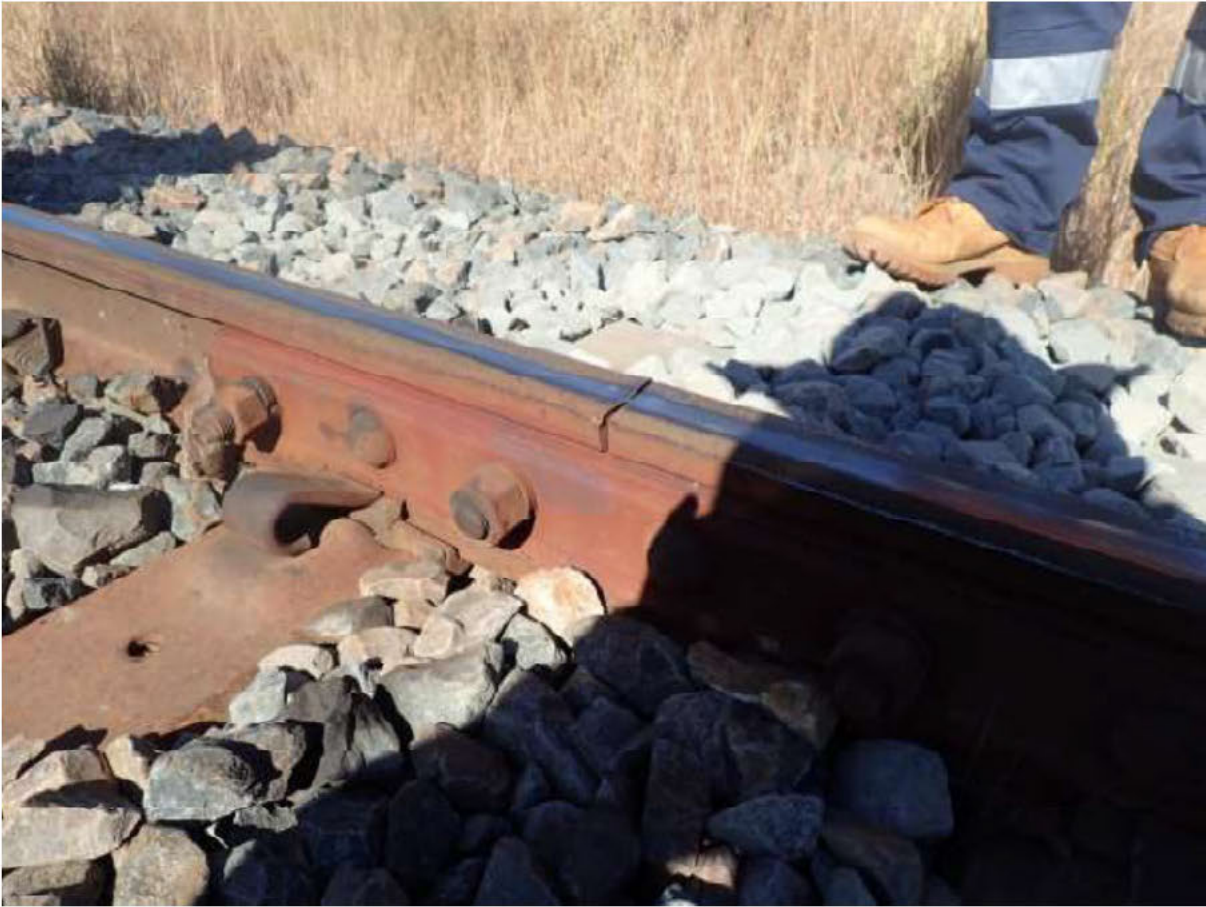
Figure 6 below shows a frozen joint, which does not allow for adequate expansion and contraction to accommodate thermal induced longitudinal movement, resulting in the ends of each rail being damaged (slightly battered).

Figure 6: Frozen joint

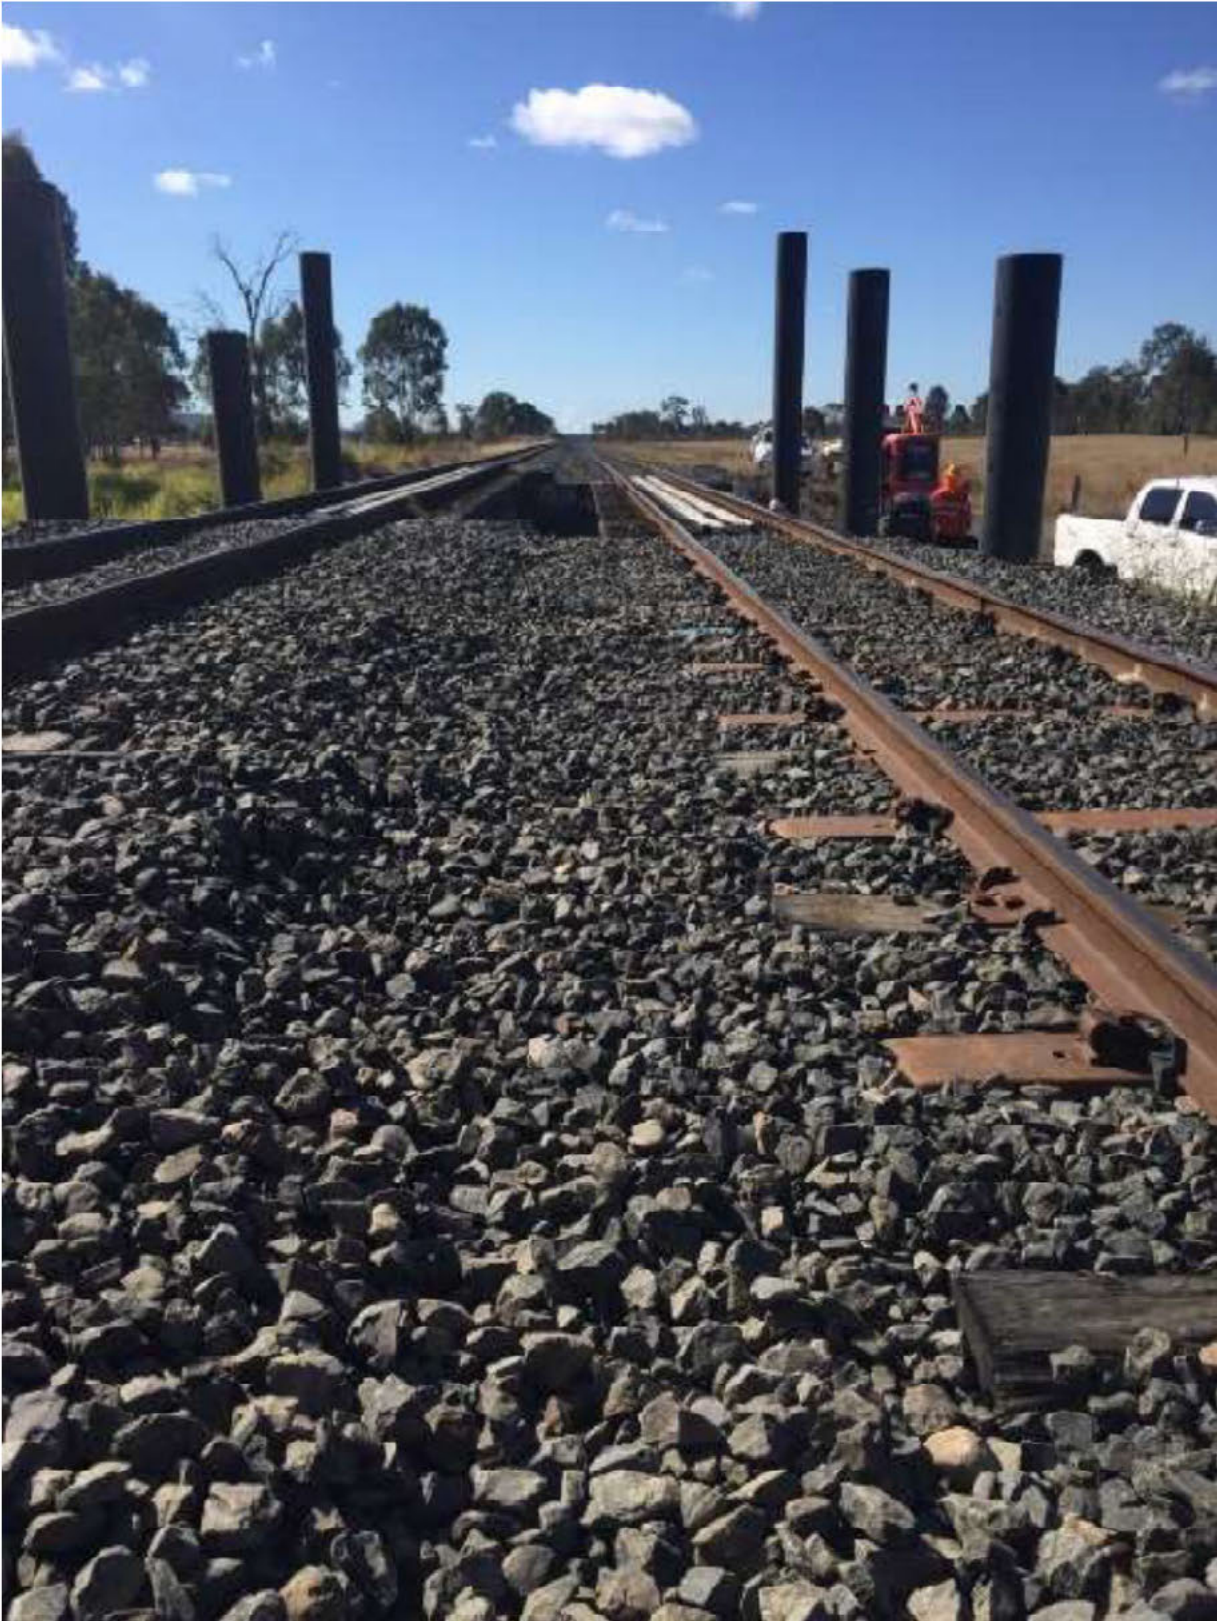
In Site 1, concrete sleepers were used on the down track, while the up track used an even mix of timber and steel sleepers instead (Figure 7).

Figure 7: Use of a mix of steel and timber sleepers on parts of the West Moreton system

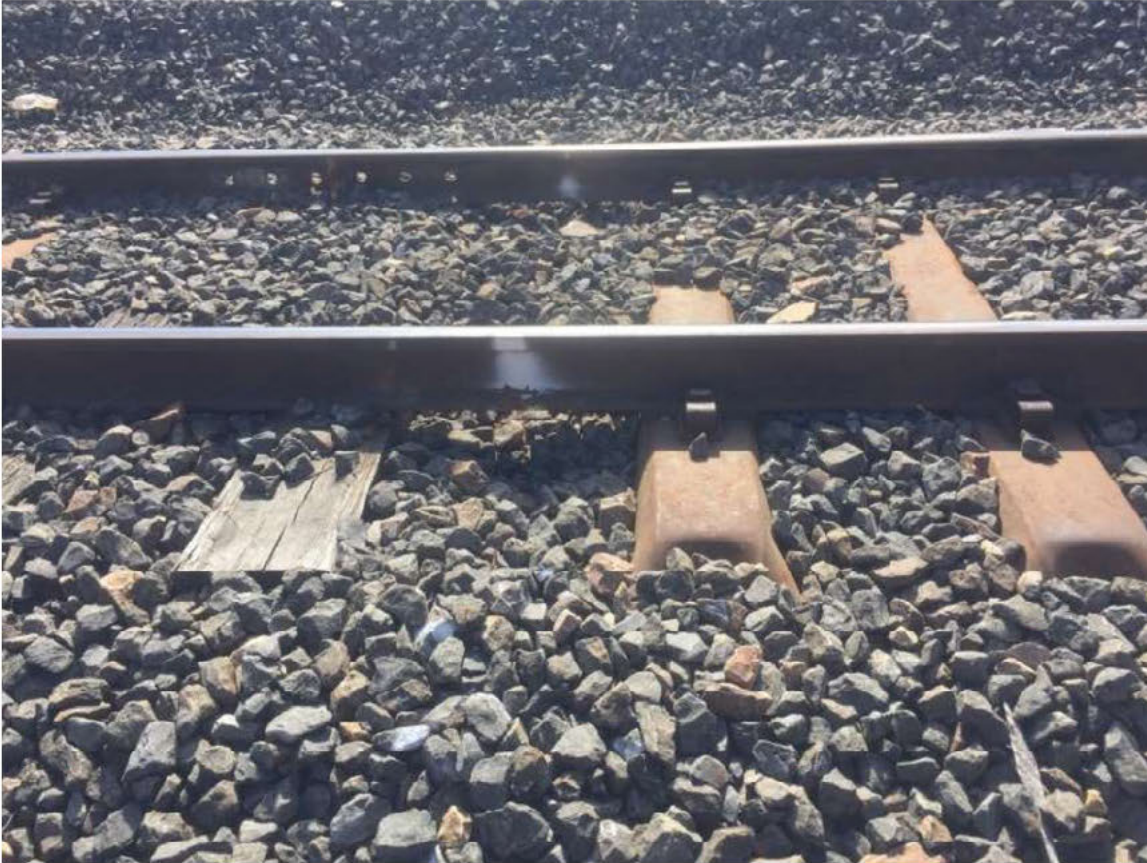
Site 2 demonstrated the need for regular and consistent sleeper management (Figure 8). Steel sleepers are lighter than concrete sleepers and are not as secure and more readily move when subject to above-rail movement. This sleeper movement is especially prevalent in the up track, due to the tight radius of the curves and additional associated stresses.

Figure 8: Mix of timber and steel sleepers

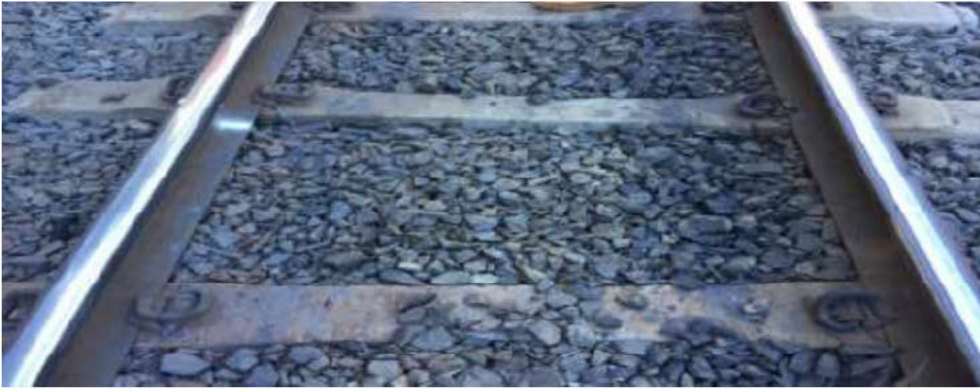
Figure 9: Skewed sleepers caused by excessive longitudinal forces

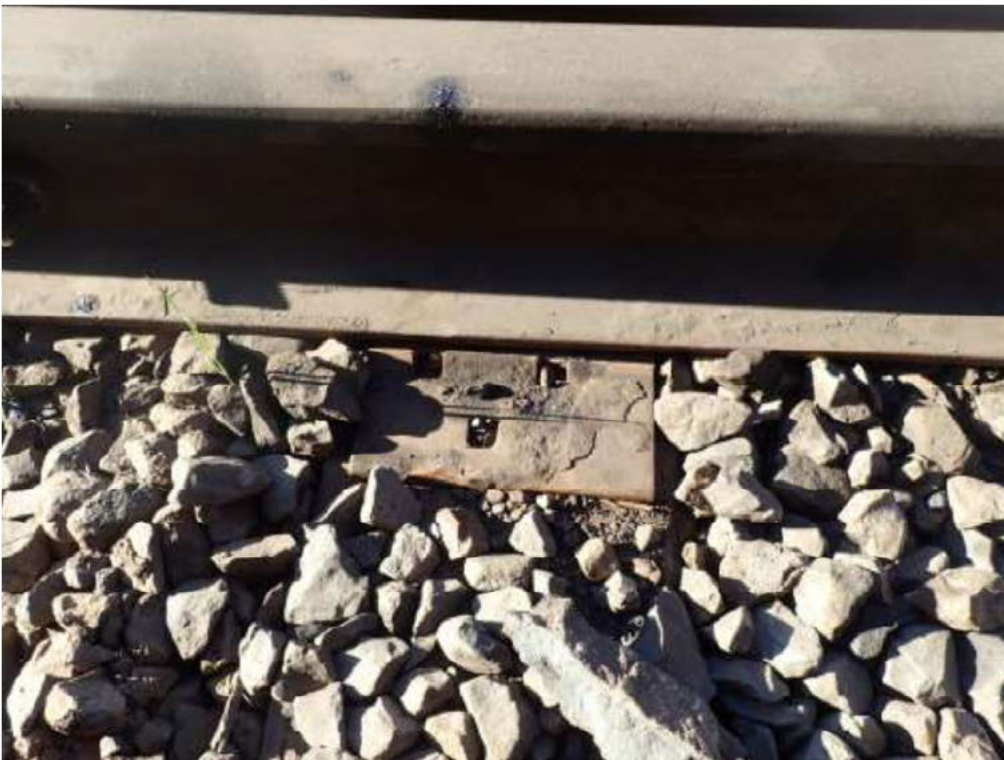
Figure 10: Missing dog spike

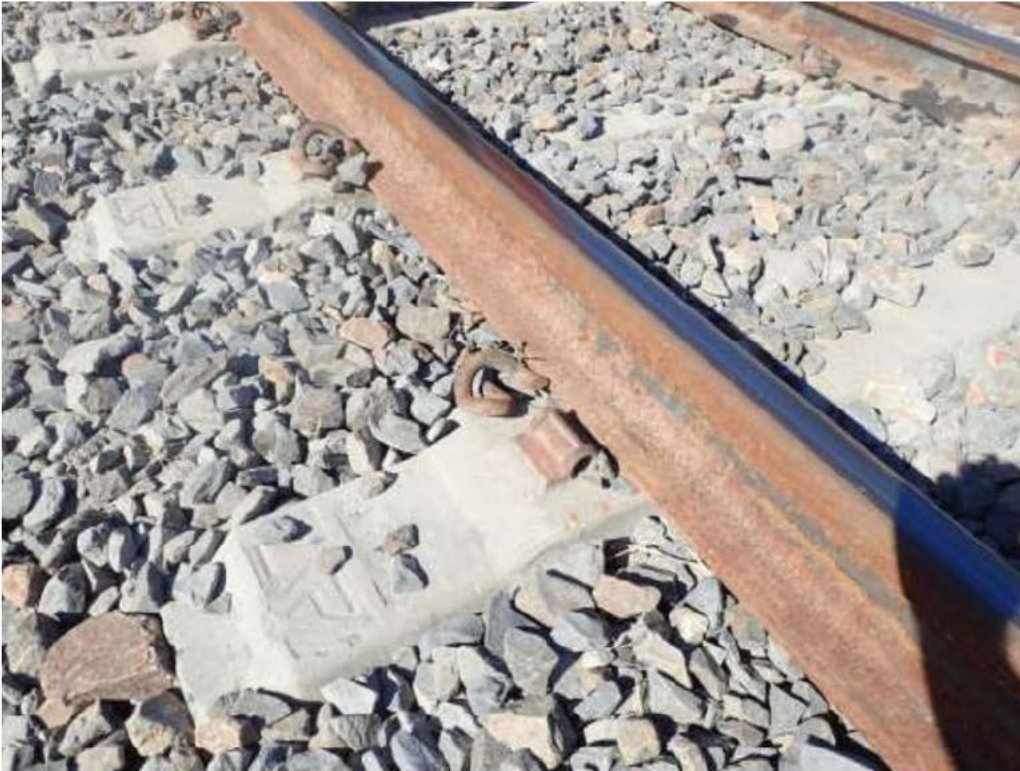
Figure 11: Missing sleeper clips and nylon

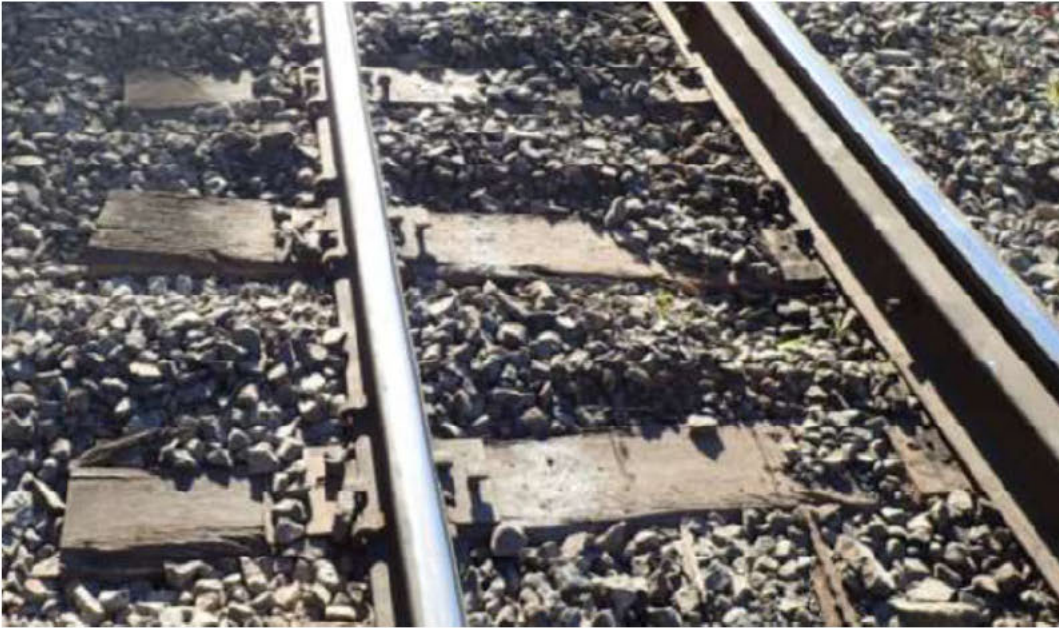
Site 8 was a similarly curved section, and experienced comparable sleeper damage and excessive lateral movement resulting in damage to the sleepers, fittings and associated alignment issues. Timber sleeper damage can be seen in Figure 12 below, which is likely a result of excessive radial loading compounded by constricted lateral movement.

Figure 12: Skewed timber sleeper splintering

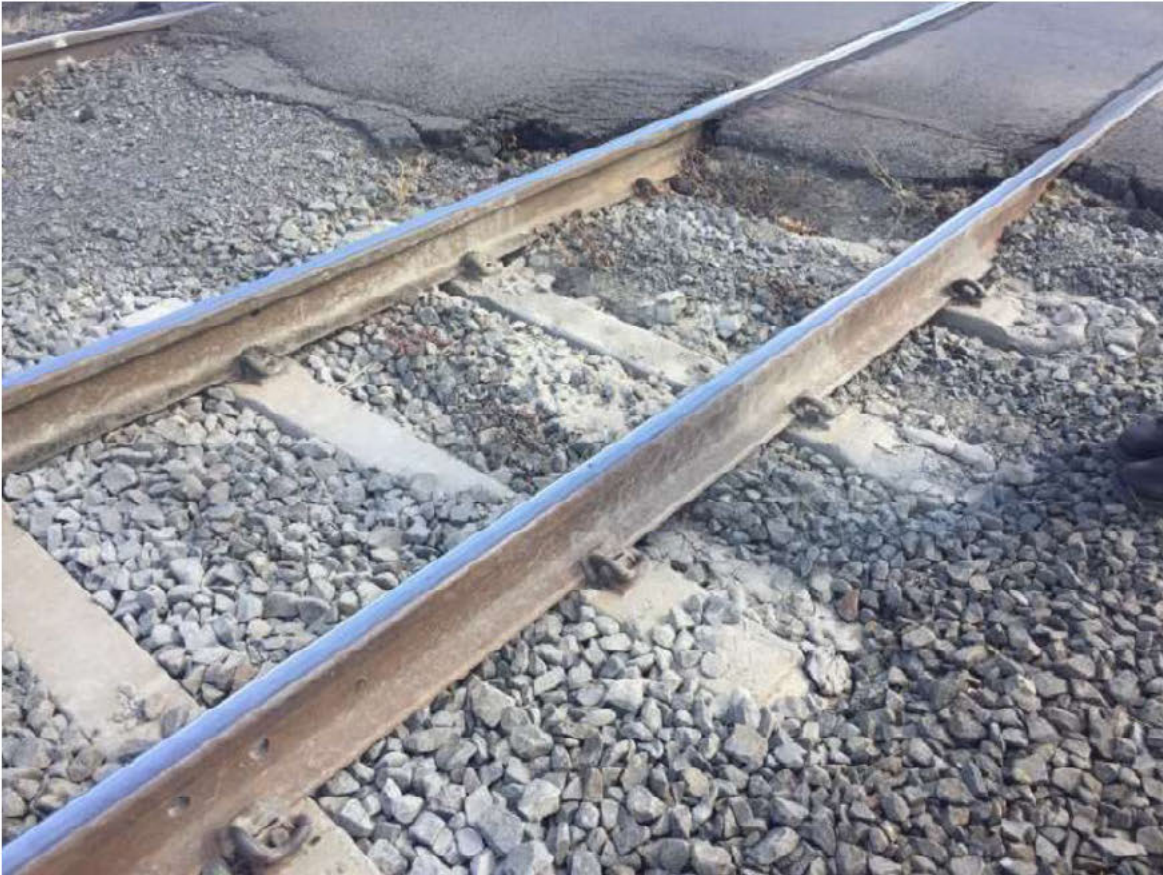
The transition between track stiffness at the level crossing and off the end of the level crossing has resulted in pumping and development of a mud hole. This ballast was last maintained over a decade ago; possibly due to the constraints which the tamper machines have in lifting the rail (the rail is firmly held by the surrounding asphalt).

These mudholes have been creeping into the asphalt, contaminating the pavement and resulting in structural failure of the subgrade below. This increases the likelihood of surface asphalt failure. Furthermore, these mudholes can cause waterlogging issues in the ballast, allow for vegetation to grow in and around the rail tracks.

Figure 13: Impact of poor drainage on the condition of ballast

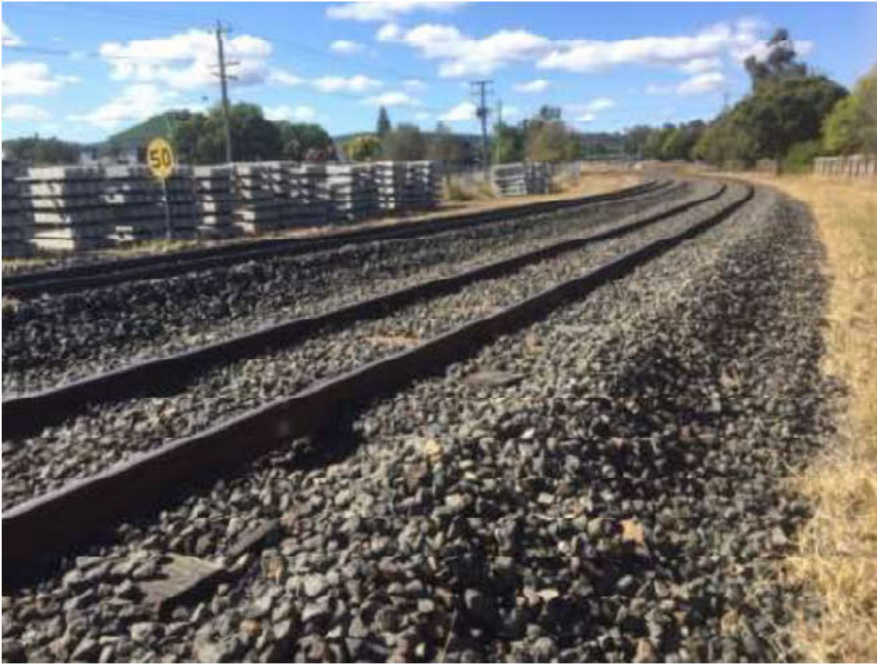
A tight radius curve leads into Site 2, adjacent to the Laidley yard (see Figure 14 and Figure 15). The track is laid on a combination of steel and timber sleepers and traverses under a low bridge (an 'overbridge'). During warmer months, the track buckles from the heat, resulting in track stability problems. We understand that Queensland Rail often cools the track with water from a water-spraying track car, with the objective of minimising track buckling.

Figure 14: Tight radius curves (1)

Since our site visit, Queensland Rail has reconditioned the track structure and replaced the interspersed steel and timber sleepers with concrete sleepers and 50 kg/m rail (as can be seen in the background of Figure 14), and used low profile concrete sleepers under the overbridge as part of its capital expenditure program.

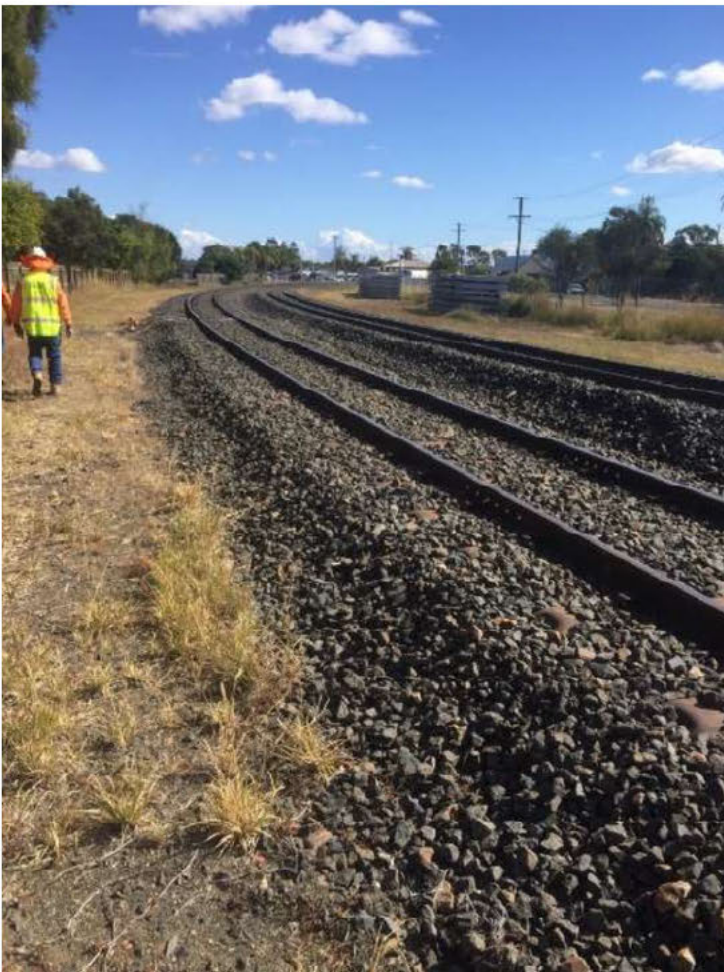
Figure 15: Tight radius curves (2)

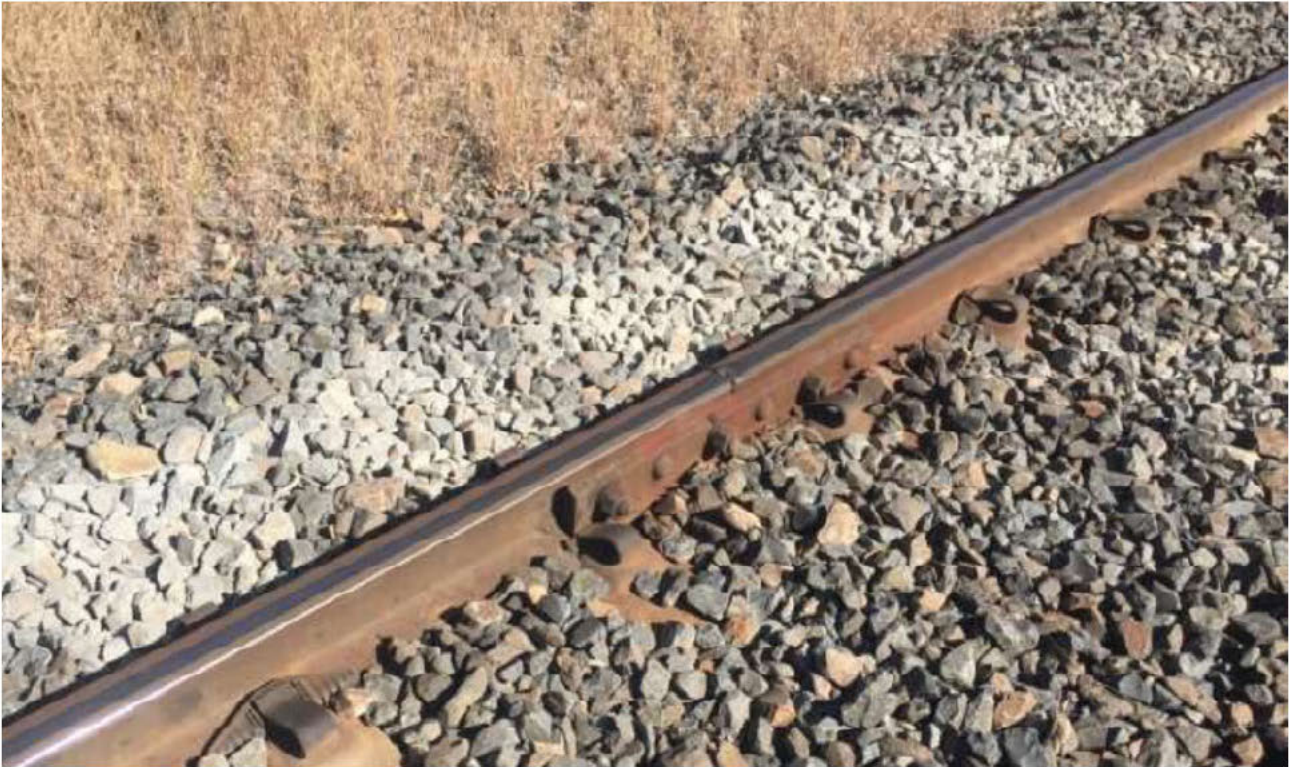
Regular 15.75 tonne axle loads and the inherent nature of the West Moreton track foundation will result in regular maintenance being required to address dipped joints and/or frozen joints. This work would be required in addition to spot joint top & lining and joint lifting to correct for localised pumping, which is caused by a combination of the greater impact loadings from increasing joint deflection and poor supporting formation. Noting our observations from the site visit (Figure 6 and Figure 18), including observing several dipped, battered and frozen joints, in addition to joint related pumping, the need for regular joint maintenance is evident.

Figure 18 Battered and frozen joint
