Civil Engineering Report

Percentage Void Contamination (PVC) Testing After Ballast Cleaning

Rev 3, 16 September 2021

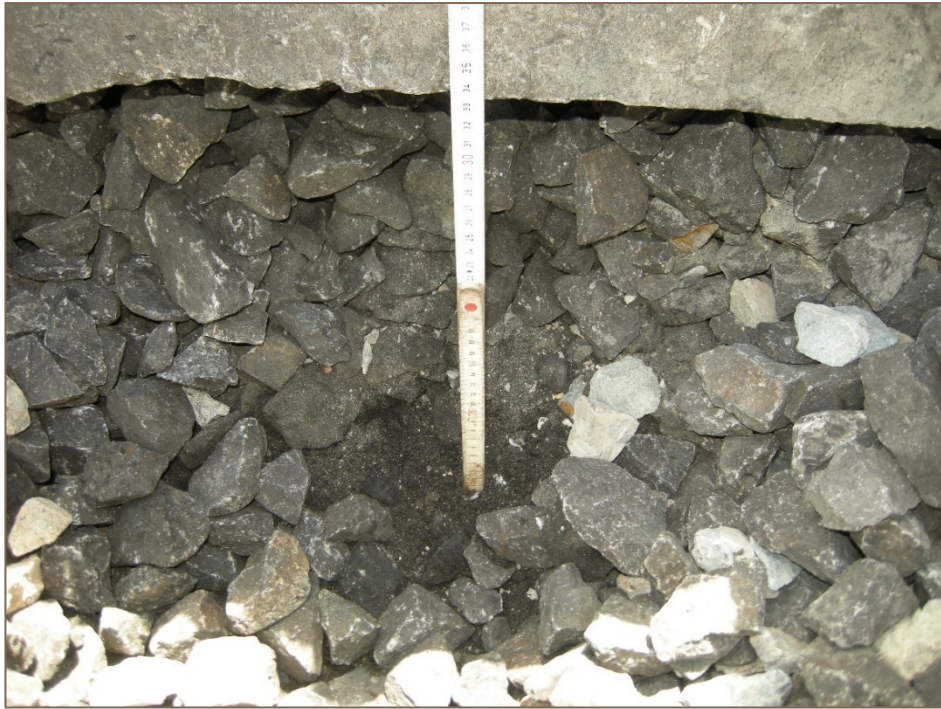
Examples of cleaned ballast with Condition Number 1 (screened as planned) are included in Figure 4 (from RM900) and Figure 5 (from RM902).

Figure 4 – Photo of ballast in sample test pit at sample site 2F, at 24.774km on the Down track on the North Goonyella Line, 14 September 2020. Lab PVC 8.6%

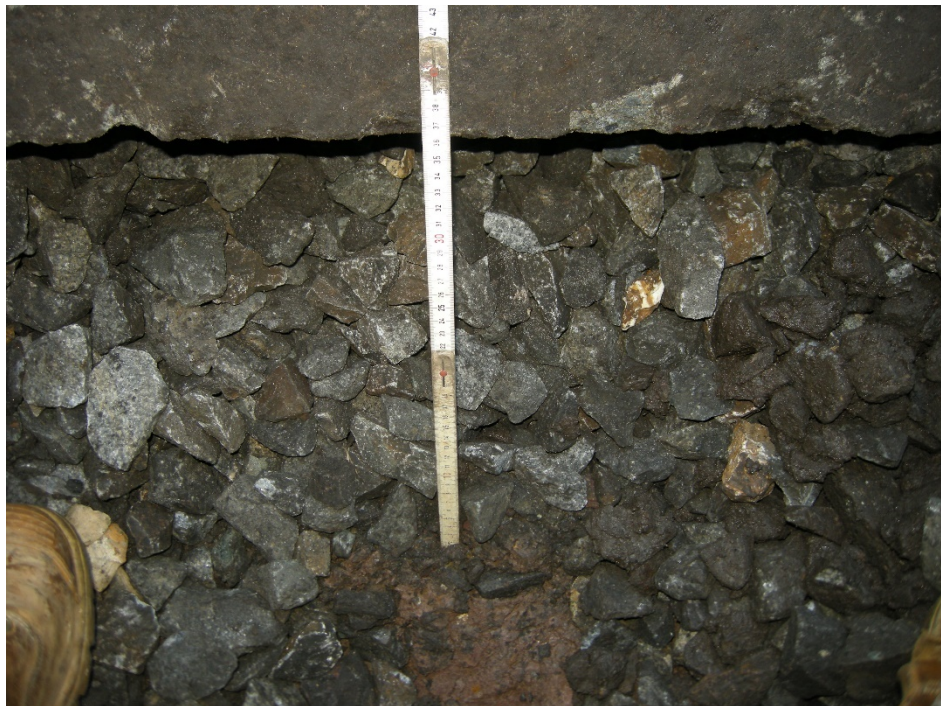
Figure 5 - Photo of ballast in sample test pit for sample 1, at 38.5km on the Down track on the North Goonyella Line, 28 July 2021. Lab PVC 3.9%

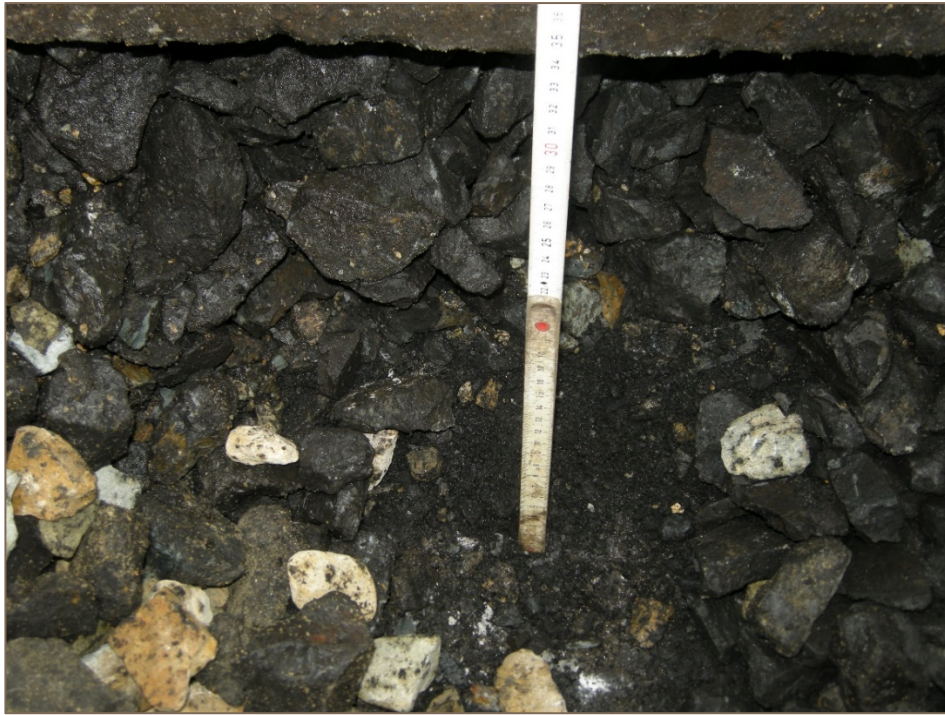
An example of ballast with Condition Number 2 (screening attempted, though ballast was classified as unscreenable after screenability assessment of pre-dig test pits, sample location 3C), is included in Figure 6.

Figure 6 – Photo of ballast in sample test pit at sample site 3C, at 555.465km on the Up track on the North Coast Line, 24 September 2020. Lab PVC 18.5%

2. The average PVC test result for Ballast Condition 2 (screening of ballast classified as unscreenable, due to unplanned circumstance, 3 samples) of 11.1% was significantly higher than the average PVC test result for Ballast Condition 1, which was expected. Until further work is done to increase the sample size, this value of 11.1% may be used for reference purposes as a typical value representing efficient screening of unscreenable ballast.

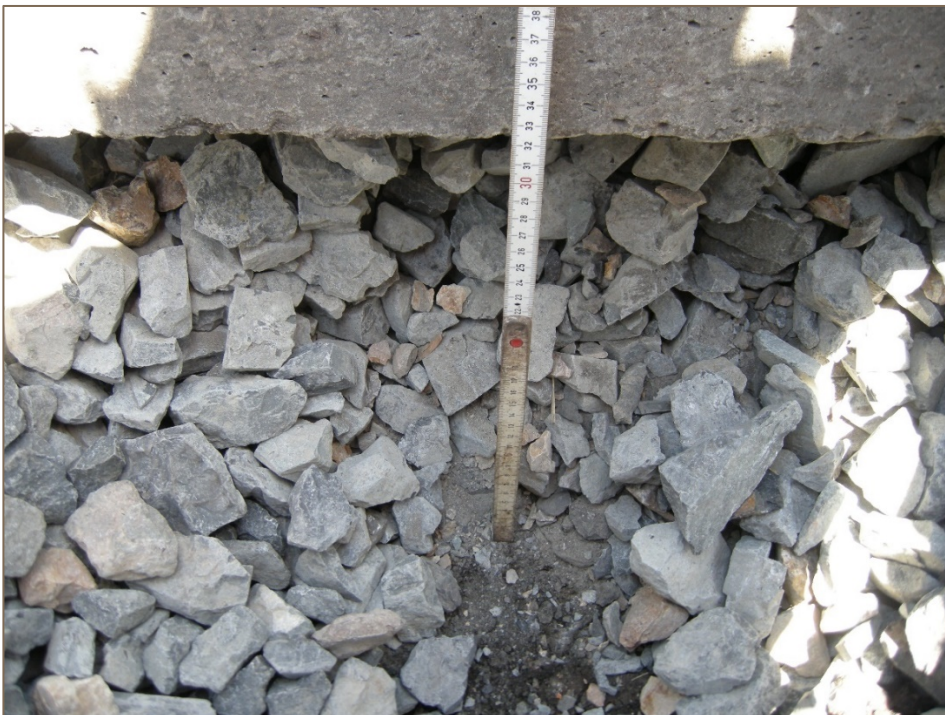
An example of ballast with Condition Number 3 (replacement ballast following total excavation, sample location 4E) is included in Figure 7.

Figure 7 – Photo of ballast in sample test pit at sample site 4E, at 65.534km on the Down track on the Central Line, 26 September 2020. Lab PVC 0.7%
