Attachment 6: GHD Peer Review of West Moreton System DAU2 Maintenance Costs 2020-21 to 2024-25

Peer review of Queensland Rail's proposed maintenance expenditure for DAU2

Queensland Rail

27 July 2018

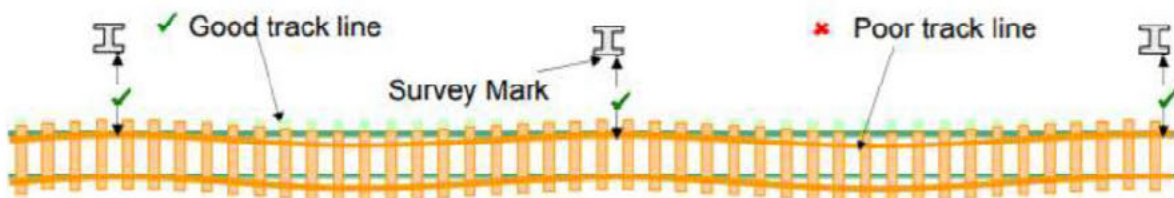
Figure 16: Rail line deviation superimposed on original track line design. Re-alignment is necessary to achieve the good track line from the deviated poor track line¹.

As the track geometry deteriorates from the specifications set out in the maintenance standards, it is necessary to resurface the track. The purpose of the mechanised-resurfacing activity is to reinstate the designed track geometry top and line, as is diagrammatically explained in Figure 16 and Figure 17. To achieve this, the resurfacing activity aims to ensure integrity of the ballast component through tamping, and to adjust the geometry by aligning the track line to pre-determined coordinates and also the track top via track lifting.
