Civil Engineering Report

Percentage Void Contamination (PVC) Testing After Ballast Cleaning

Rev 3, 16 September 2021

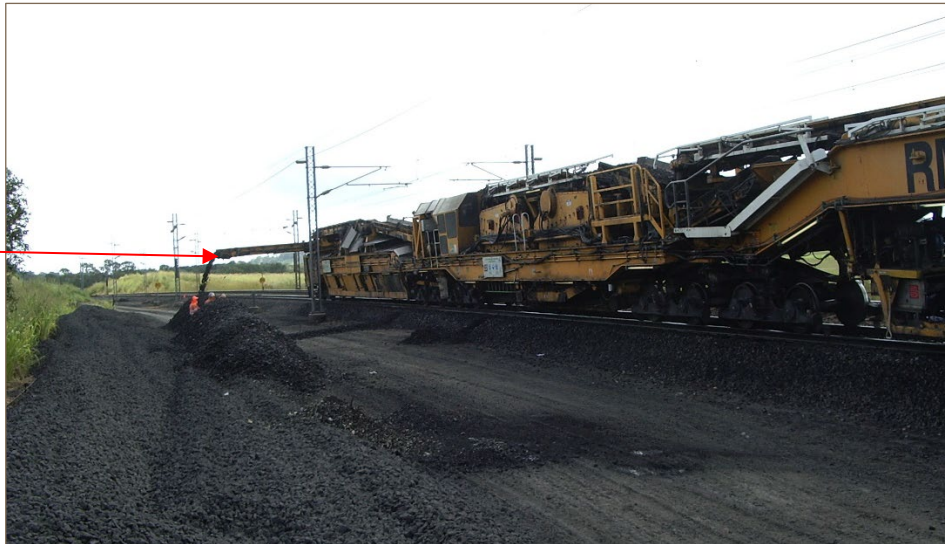
Figure 3 – RM900 discharging material (unscreenable ballast and/or screened fouling material)

Unscreenable
or screened
fouling material
discharged
from RM900
