Aurizon Network Pty Ltd – Management of Ballast Fouling in the Central Queensland Coal Network

Management of Ballast Fouling in the Central Queensland Coal Network

A review of Ballast Management 2010 - 2017

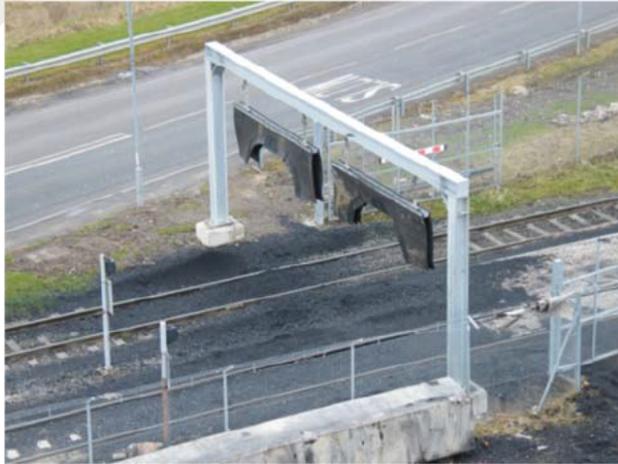
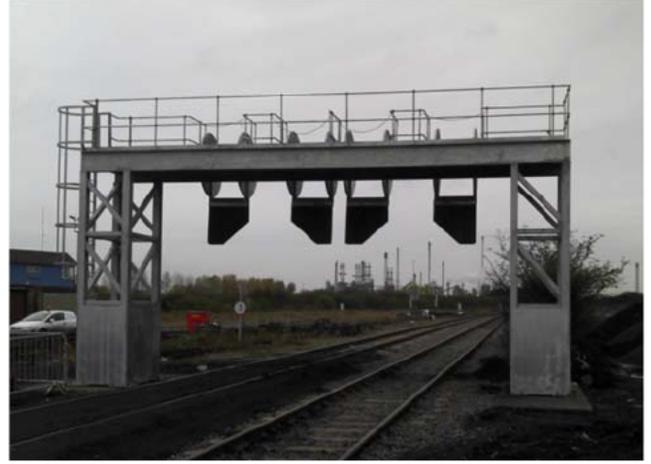
Figure 5. Example of UK coal rudimentary profiling facility

The United Kingdom completed a detailed review of its coal loss practices and as a result, implemented mitigation activities which included the installation of the facilities shown in Figure 5.

These facilities perform basic profiling and brush the raves (the wagons vertical sidepieces) to clear them of any residual coal. It is noted in the report to the Office of Rail Regulation in 2013 that as a result of the installation of these facilities, coal spilled outside of terminals has been reduced by 75%¹⁶.
