Management of Ballast Fouling in the Central Queensland Coal Network

A review of Ballast Management 2010 - 2017

Updated 24 February 2015 – Removal of Redactions

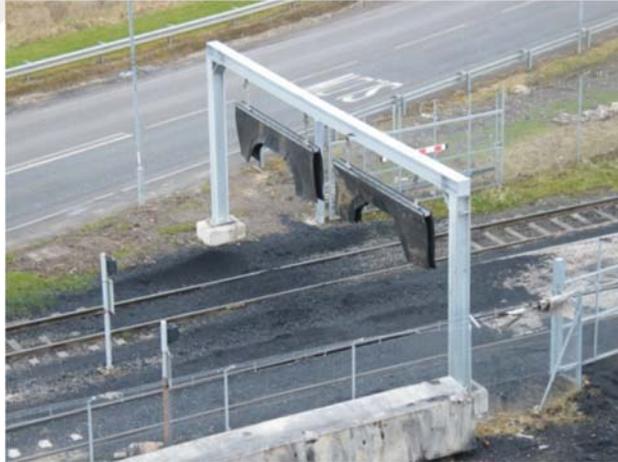
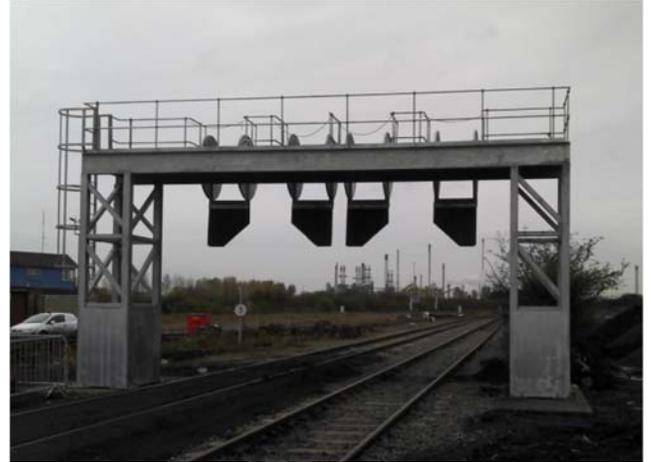
Figure 5. Example of UK coal rudimentary profiling facility

The United Kingdom completed a detailed review of its coal loss practices and as a result, implemented mitigation activities which included the installation of the facilities shown in Figure 5.

These facilities perform basic profiling and brush the raves (the wagons vertical sidepieces) to clear them of any residual coal. It is noted in the report to the Office of Rail Regulation in 2013 that as a result of the installation of these facilities, coal spilled outside of terminals has been reduced by 75%¹⁶.
