SunWater Price Regulation

REVIEW OF SELECTED ANNUITY VALUES FOR
REFURBISHMENT AND REPLACEMENT ITEMS -
ADDENDUM

- Final
- 3 April 2012

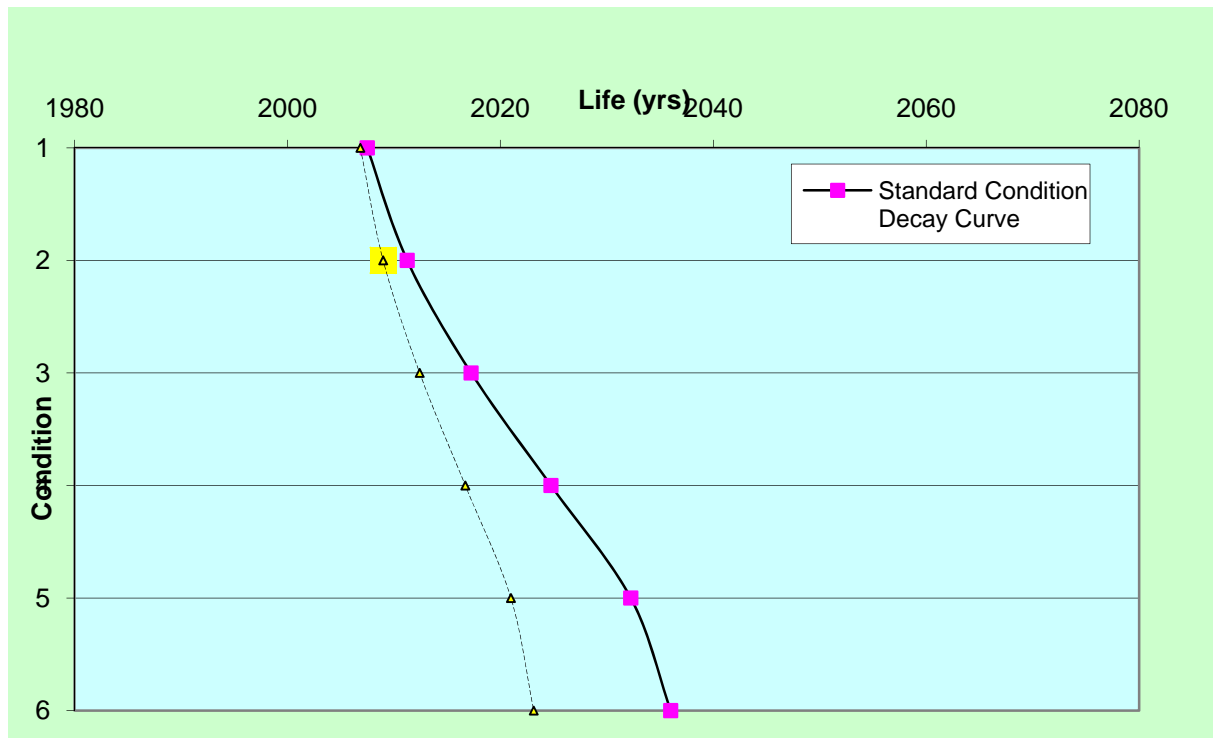
We have viewed the WMS record for this asset and confirmed that the asset has been in service since 1978. SunWater has applied its risk evaluation method to this asset and determined the risk, during the most recent risk assessment in 2008. This risk assessment yields a highest consequence score of 3 with a probability of 10 resulting in an overall risk score of 30 (ie Low Risk). For this asset type, an overall risk category of low with a consequence score of less than or equal to 8 does not lead to a risk related adjustment to the replacement date for the asset. A condition assessment for the asset was undertaken in 2008 (within the required frequency). The condition assessment indicates that the highest condition score allocated was a 3 (Minor defects only). Applying the condition assessment score and risk rating to SunWater's Condition Based Replacement Life Adjustment Tool results in a forecast run to failure life of 40 years and a projected replacement date of circa 2033.

The asset (including pumps and motors) is scheduled for replacement in 2032, and has an expected life of 30 years. However, from examination of the SAP, SKM understands the common controls were last replaced in 1993. With the knowledge of the obsolescence which usually affects this type of control equipment regardless of condition, SunWater would normally assume a standard run to failure asset life for this asset and scheduled replacement at the end of that life, i.e. 1993 installed date plus 15 years standard life gives a 2008 replacement date. The run-to-failure life has therefore already been exceeded. From SAP WMS we note that SunWater has planned to reprogram the SCADA in 2012 in line with a planned pumps and motors upgrade study. SunWater has therefore decided to extend the life of the asset (common controls) in line with the run to failure life extension projected by SunWater's Condition Based Replacement Life Adjustment Tool.

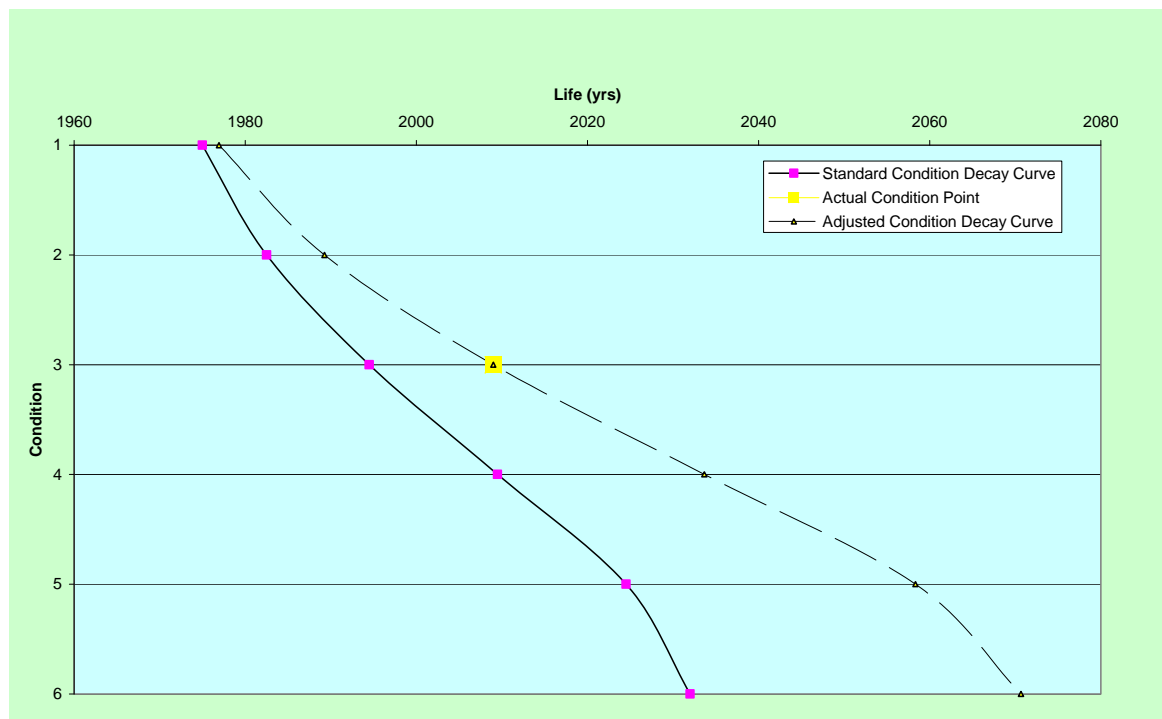
■ **Figure 2 Asset Condition Decay Curve for Winches Showing Inspection Condition**

The last condition assessment (in 2009) revealed that the condition of the asset is better than the standard asset condition decay curve would predict, which would normally suggest that the life of the asset could be extended beyond the standard run to failure life (see Figure 2). However, as SunWater has assessed the risk of failure category as high, under SunWater's asset management systems an asset with a risk category as high is to be replaced when a condition score of 4 is reached (i.e. the asset isn't allowed to run to failure but is to be replaced prior to this).

From Figure 2, the asset will reach condition level 4 in approximately 2030 which would suggest that a replacement date of 2030 should be planned for. That said, given the criticality of the asset, and the imprecise nature of the life extension projection mechanism² of the condition based replacement life adjustment tool, we consider that it is appropriate for SunWater to plan for a replacement of the winches at Jack Taylor Weir at or around the standard run to failure asset life i.e. 2020.

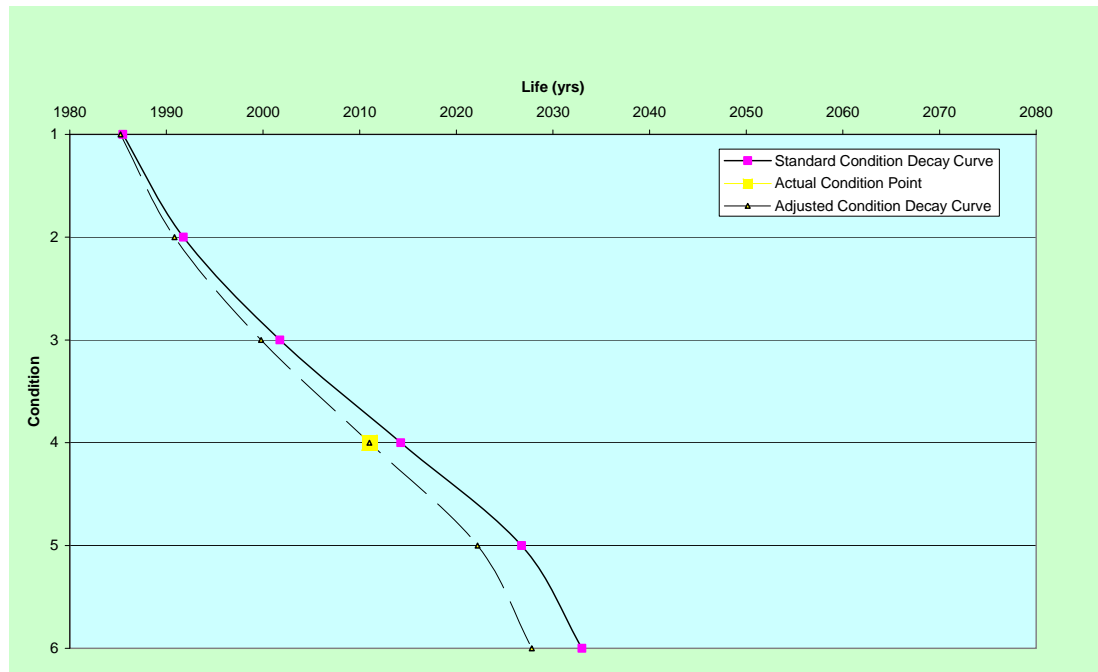
■ **Figure 3 Condition Decay Curves**

This is indicated in Figure 3, which is an extract from the “Oakendon Main Channel Replace AVIS Gates” document. The standard condition decay curve predicts the replacement year as 2033 and the Adjusted Condition Decay Curve predicts the replacement year as 2028.

However, as mentioned, SKM supports SunWater’s decision to replace the Avis gate in 2033 given the asset’s low risk rating and that the asset will be re-inspected/refurbished before 2028 and that, should the condition at that time warrant it, the planned replacement date could be brought forward.
